Environment, Health and Safety Hazard Alert

Title: Bunsen Burner Flash Fire

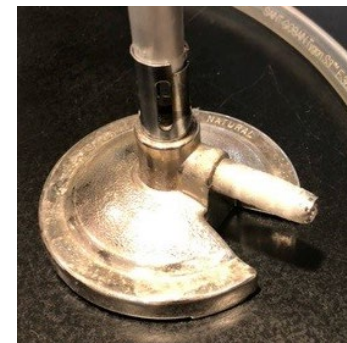
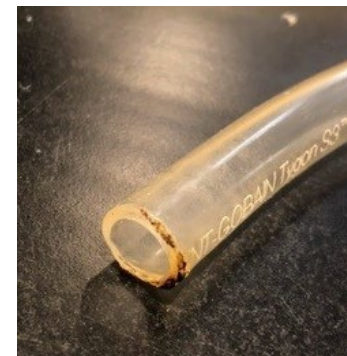
- The tubing to connect the Bunsen burner was too wide for the burner nozzle.
- The mismatch of the tubing was improperly addressed by wrapping the nozzle with parafilm instead of replacing the tubing.
- The improper fit of tubing to the nozzle resulted in a gas leak at the connection which ignited when the burner was lit.
- Lab personnel did not notice the improper fit of tubing and the gas leak at the connection when inspecting the burner setup.

- Bunsen burner tubing was replaced with one that has a proper fit to the nozzle.
- A written Standard Operating Procedure (SOP) was prepared and used to retrain lab personnel on how to work safely with a Bunsen burner.
- Working with Bunsen burner was included as task in hazard assessment and SOP, and properly sized tubing were included as controls.

- Ensure a proper fit of tubing at all connections without the need for aids such as parafilm.
- Always inspect tubing and check all connections for leaks prior to lighting the Bunsen burner.
